Manhole Inspection Summary

Manhole # S15EE_007MH

Insp Date: **5/13/09 11:33 AM**

Location Address: **REAR 2777 LONGWOOD**

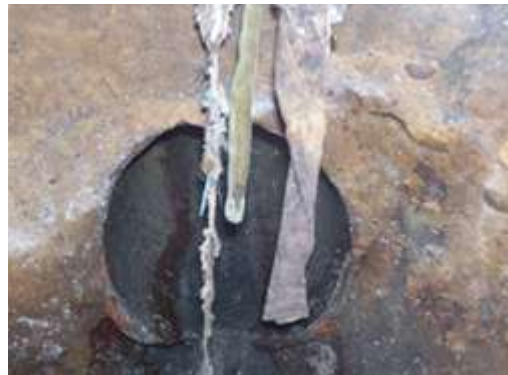
Defect 1

Surcharge ☒ **Evidence Of Surcharge** Depth: **12** (ft.) ☐ Active Surcharge Present

EVIDENCE OF SURCHARGE

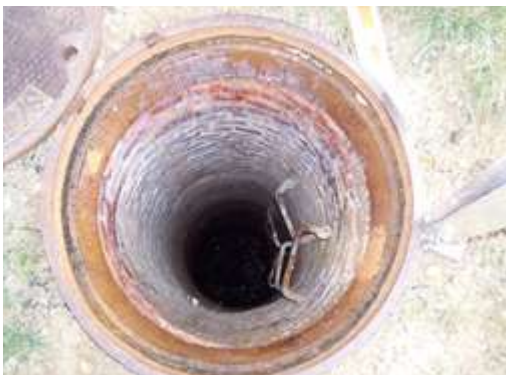
Defect 2

EVIDENCE OF SURCHARGE

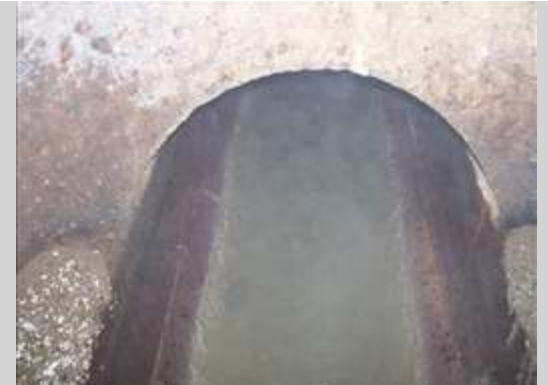
12 O'Clock Outflow

27 in. Circular Gravity Sewer
Pipe Out @ 12 O'Clock

Pipe Height: (in.) Direct
Pipe Material: **Clay** ☐ Pipe Lined
Invert Depth: **29.89** (ft.) Flow Characteristics: **Fast**
Deposits: ☒ None ☐ Mud ☐ Sludge ☐ Debris ☐ Grease
Silt Depth: (in.) Deposits Extent:
Infiltration: **None** Pipe Seal Cond: **Sound**

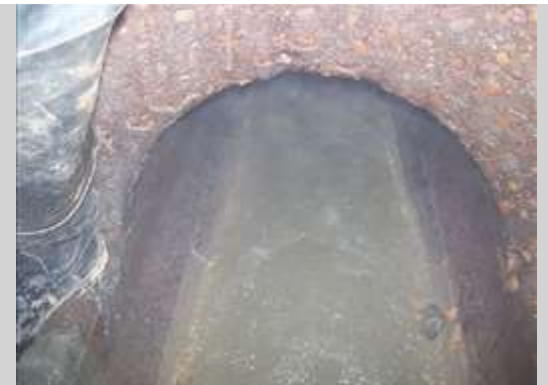
6 O'Clock Inflow

27 in. Circular Gravity Sewer
Pipe In @ 6 O'Clock

Pipe Height: (in.) Direct
Pipe Material: **Clay** ☐ Pipe Lined
Invert Depth: **30.00** (ft.) Flow Characteristics: **Fast**
Deposits: ☒ None ☐ Mud ☐ Sludge ☐ Debris ☐ Grease
Silt Depth: (in.) Deposits Extent:
Infiltration: **None** Pipe Seal Cond: **Sound**

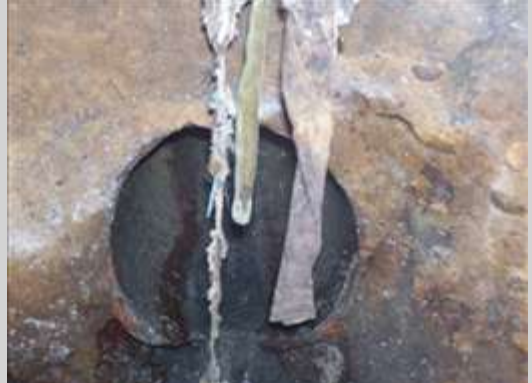
Pipe In @ 9 O'Clock

6 in. Circular Gravity Sewer

Invert Depth: **24.60** (ft.) Flow Characteristics: **Slow**

Infiltration: **None** Pipe Seal Cond: **Sound**

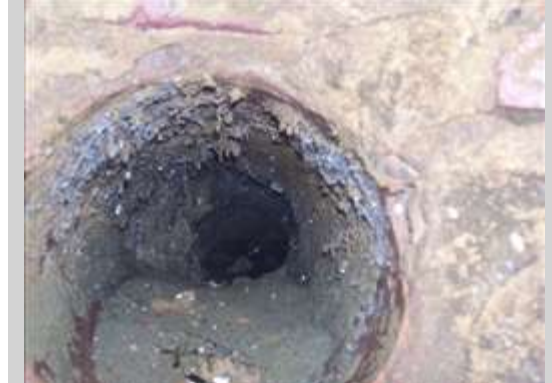
Drop In @ 9 O'Clock

Drop: **Outside** **Direct**

Inv Depth: **30.00** (ft.)

Drop Condition: **Open**
